# Why Are So Many People Unhappy With Their Knee Replacement?

*...And what is ConforMIS doing to fix it?*

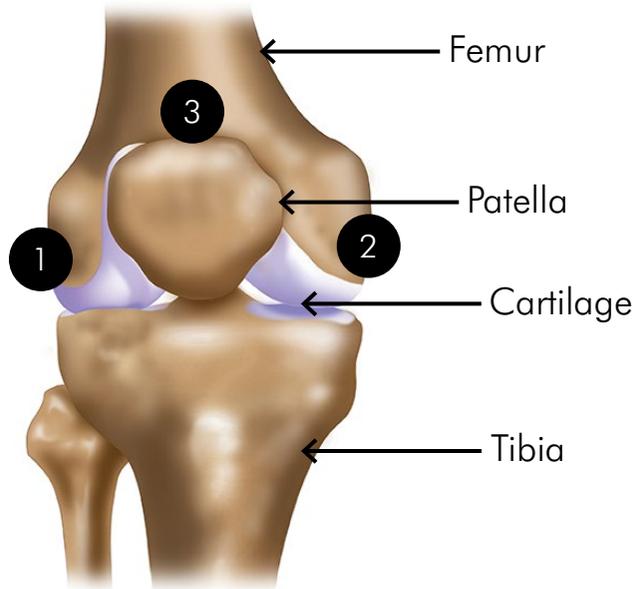
Your knee also has three compartments:

- 1 **Lateral** compartment (outer half of your knee)
- 2 **Medial** compartment (inner half of your knee)
- 3 **Patellofemoral** compartment (behind the knee cap)

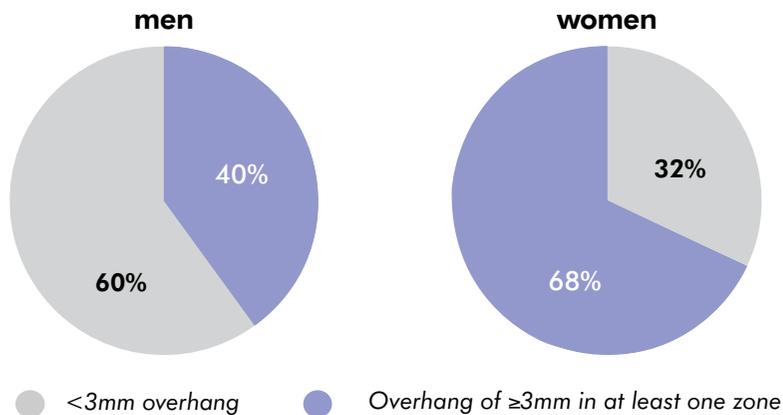
Poor implant fit can result in **overhang**, which causes pain and dissatisfaction after surgery.

Every knee has a unique shape and size and its virtually impossible for off-the-shelf designs to fit each one. The result is oftentimes implant overhang, which can be painful because the metal rubs against the surrounding soft tissues.

- In a study of 437 knee replacements, **57% of patients had overhang  $\geq 3\text{mm}$  on the femoral component.**<sup>2</sup>

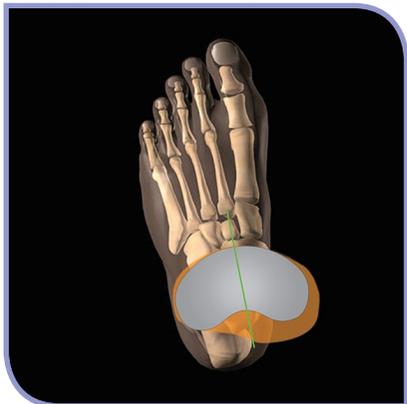
This implant is properly rotated; however, it leaves a lot of bone uncovered.

Off-the-shelf implants force compromises on tibial component rotation

- Bone
- Implant
- Correct rotation
- Actual rotation

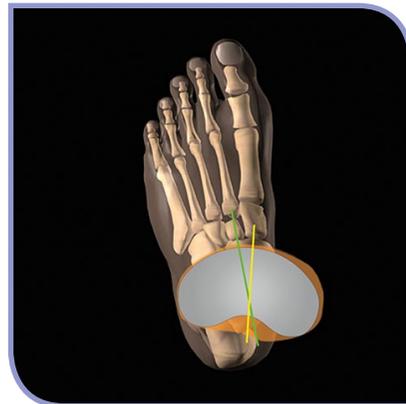
This implant covers the bone well, but it is not rotated properly.

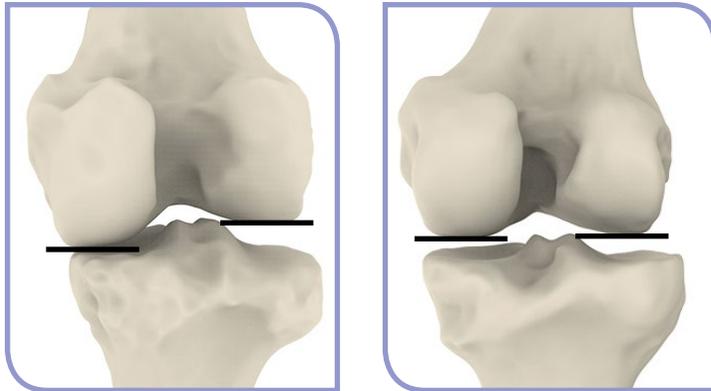
The knee has a naturally occurring offset. This offset creates what is called the **joint line**. Some people have a large offset, which means that the medial condyle, or the inside of the knee, is lower than the lateral condyle, or the outside of the knee (Patient A). Other people have a fairly flat joint line (Patient B). Maintaining the patient's natural joint line is very important in knee replacement surgery. If this isn't done correctly, the patient may experience **mid-flexion instability**. This means that at the point between complete flexion and extension, or when your knee is slightly bent, you may feel instability in your knee.

Joint line movement has been shown to change how the knee moves and lead to mid-flexion instability. Off-the-shelf knee implants aren't designed to match the normal offset joint line that most patients have. Instead, they flatten the offset to the same height.

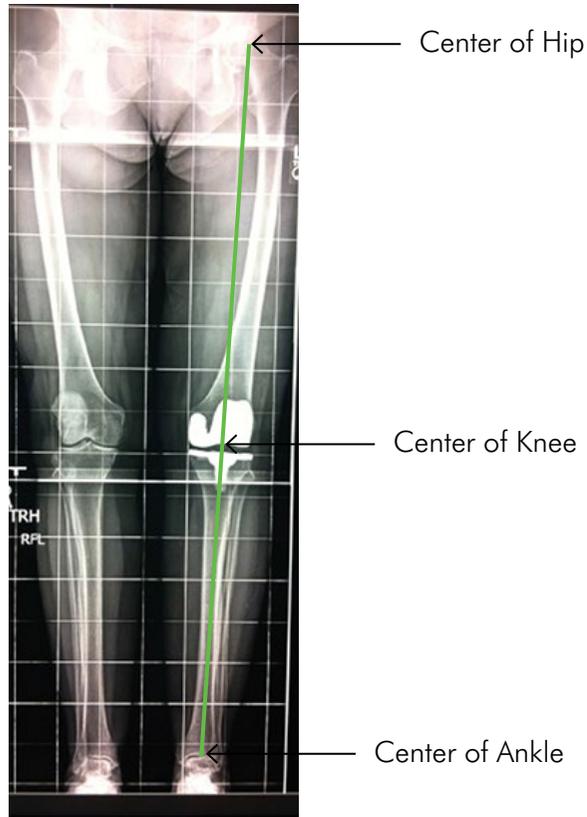
An important step in knee replacement surgery is to align the knee along the **neutral mechanical axis**, which is shown in green in the diagram above. This axis is a straight line drawn through the center of the hip, knee, and ankle.

Proper alignment to neutral mechanical axis is associated with increased stability and a lower rate of implant component loosening.<sup>8</sup> However, proper alignment is often sacrificed to make off-the-shelf implants fit as best as possible.

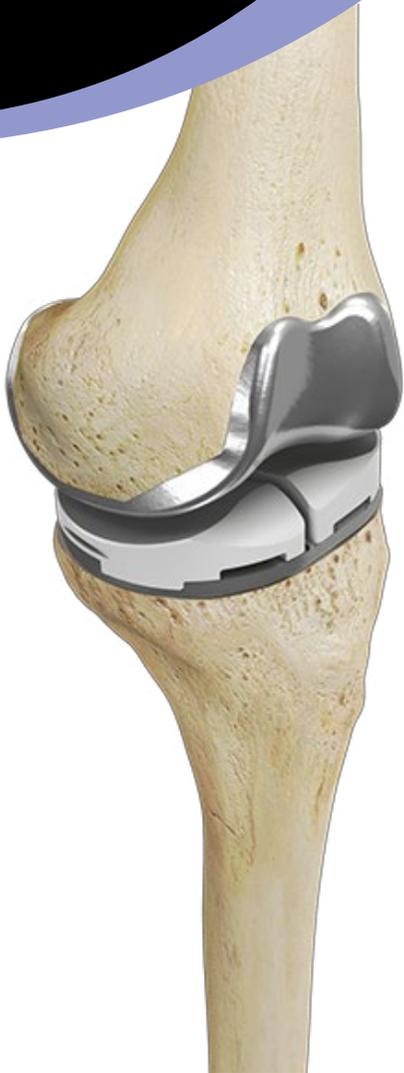
ConforMIS recognizes the limitations associated with off-the-shelf total knee replacement. This is why we design and manufacture **customized knee implants** and surgical instrumentation that are unique to your knee's natural shape and size. We believe that this customized approach could help reduce the 20% dissatisfaction rate with total knee replacement surgery.

CAUSES OF DISSATISFACTION	THE CONFORMIS APPROACH
<b>Poor Implant Fit</b>	ConforMIS implants are designed based off a CT scan to fit the unique size of each patient's femur and tibia. This virtually eliminates sizing compromises that could result in painful implant overhang.
<b>Rotational Errors</b>	Proper rotation of ConforMIS implants is determined prior to surgery based on a pre-operative CT scan. Implants are then designed with precise fit and with proper rotation built in. As a result, there is less risk of the surgeon having to compromise between fit and rotation.
<b>Poor Function and Mid-Flexion Instability</b>	ConforMIS implants restore each patient's natural shape by replicating the unique curves of their knee. By replicating these curves, we also maintain the patient's natural joint line, which can increase the potential for a more natural feeling knee and restore function.
<b>Poor Alignment</b>	iFit® Image-to-Implant® technology determines the mechanical axis of the knee using the center of the hip, femur, tibia, and ankle shown in the pre-operative CT scan. Patient-specific implants are designed with built-in alignment to this mechanical axis.
